HO-949 8110 Washington Boulevard Waterloo vicinity

Maryland Historical Trust Maryland Inventory of Historic Properties Form

HO-949

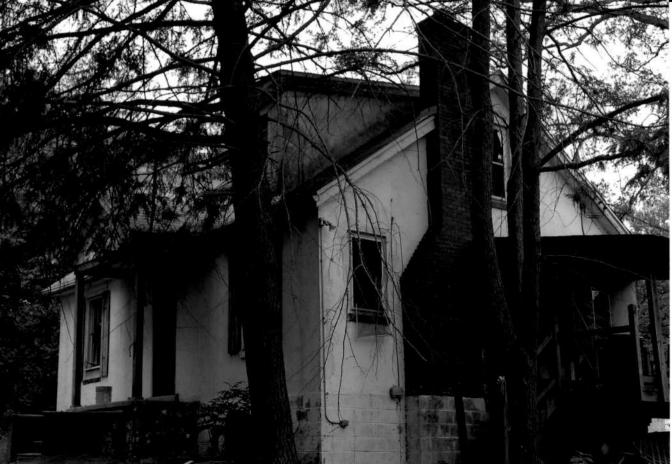
HO-0949_20070914_01 Southeast & northeast elevations

> 9-14-07 Doutheast and northeast elevations

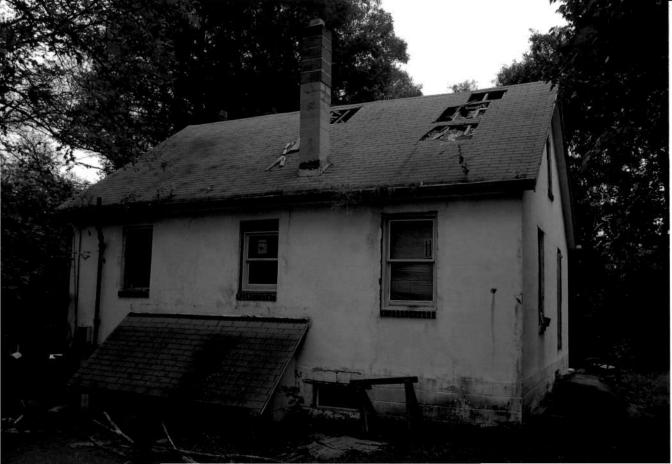
HO-0949_20070914_02 Northwest elevation

HO-949 8110 Washington Blod Howard Co. MD Ken Short, photographer Horthwest elevation 9-14-07

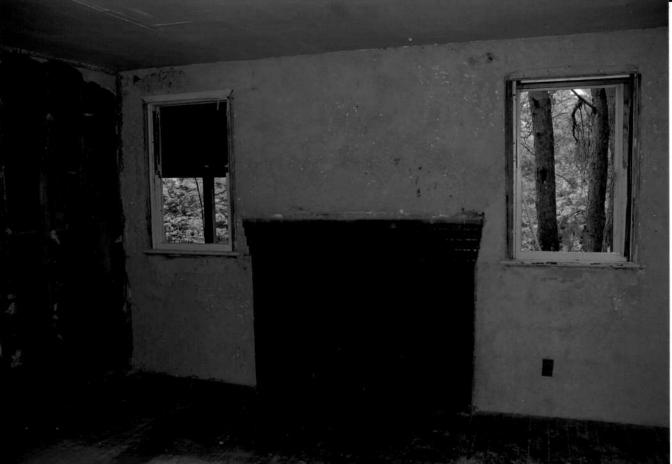
The interior has an open stringer stair in the center that ascends to the northwest, with a partition on the southwest side of the stair. The east room has a fireplace on the northeast end, with a brick mantel. The walls are drywall, which appears to be original. There are also rooms in the south, west, and north corners, and two chambers upstairs.

HO-0949_20070914_03 East room, view northeast

> 9-14-07 East room, view northeast 3/4

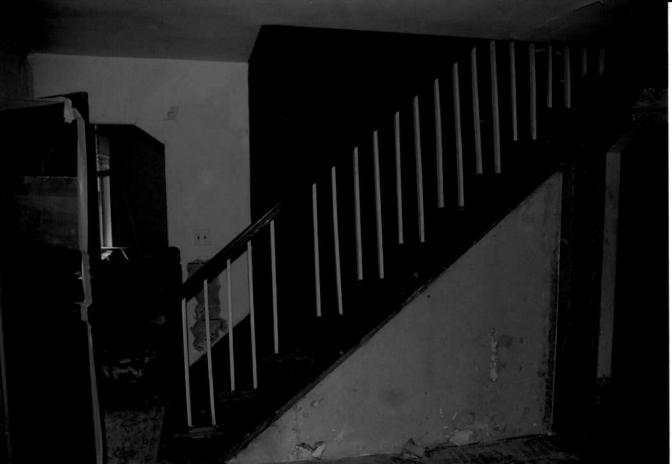
HO-0949_20070914_04
East room, view southwest to stairway

1111 40-949 8110 Washington Blod Howard Co. MD Ken Shart, photographer 9-14-07 East room, southwest to
